A Report on

Smart Agriculture-based Grape Field Environment Monitoring System

E&TC Department, SITRC

Retrofitting Brown-field Smart Agriculture-based Grape Field Environment Monitoring System

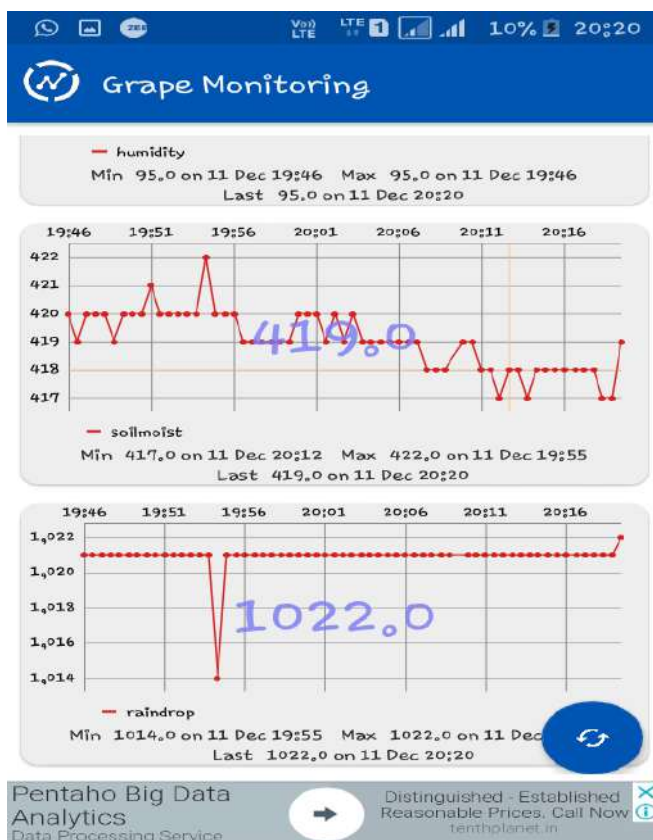
Figure shows the readings of the amount of moisture level present in soil of farm and status of the current rain fall (Whether rain-fall occurred or not)

Level of soil Moisture: 419.0

Conclusion: Soil is near to get dried, need to provide water

Rainfall sensor value: 1022.0

Conclusion: no rainfall

Fig: Soil moisture level and rain drop sensor readings

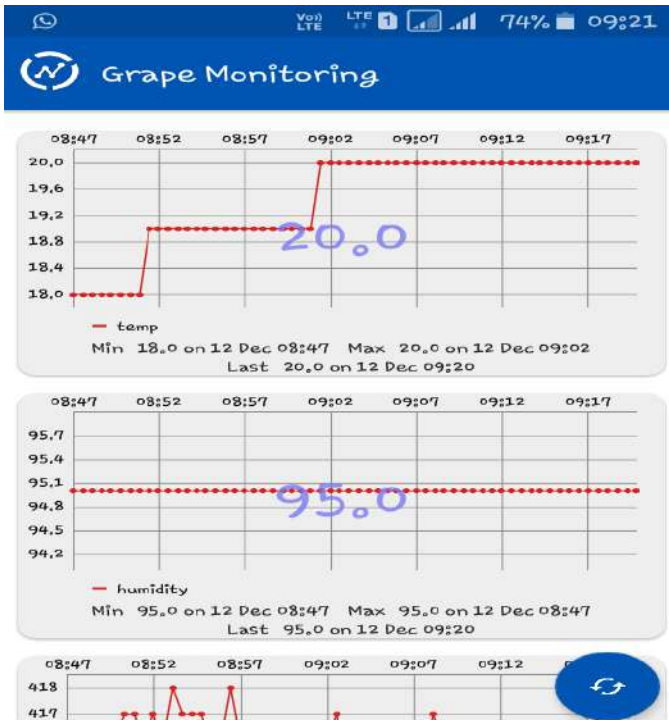
Monitored on Smart phone at time 09:20 on 12 Dec 2017

Figure besides shows the readings of the temperature and humidity.

Temperature: 20.0 Degree Centigrade

Conclusion: As per the winter season, temperature at morning has increased compared to night readings

Humidity: 95%

Conclusion: humidity remains same, since reading has taken early in morning

Fig: Temperature and Humidity readings

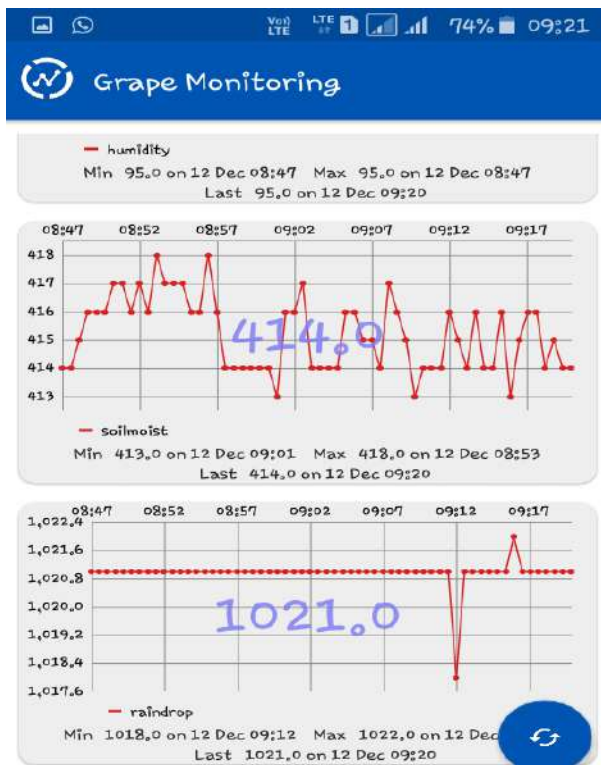
Figure shows the readings of the amount of moisture level present in soil of farm and status of the current rain fall (Whether rain-fall occurred or not)

Level of soil Moisture: 414.0

Conclusion: Reading is lowered compared to night readings, Soil is near to get dried, need to provide water

Rainfall sensor value: 1021.0

Conclusion: Same reading as night since no rainfall from night till this time

Fig: Soil moisture level and rain drop sensor readings

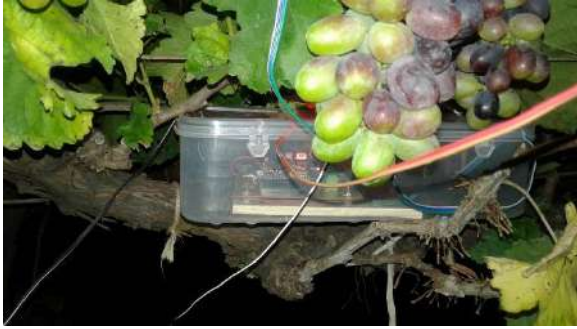
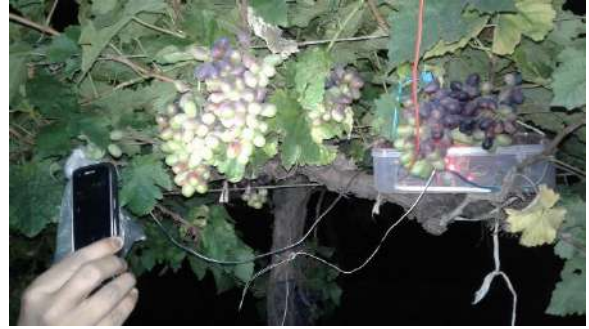
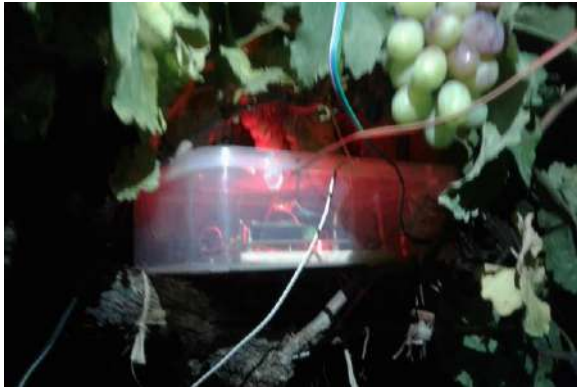
Fig: Actual Project deployed on Grape tree

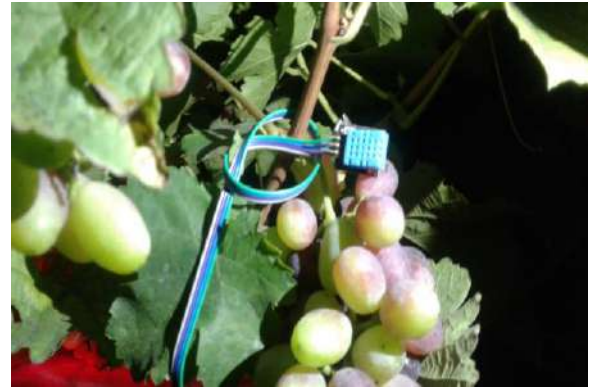
Fig: Humidity and Temperature Measurement

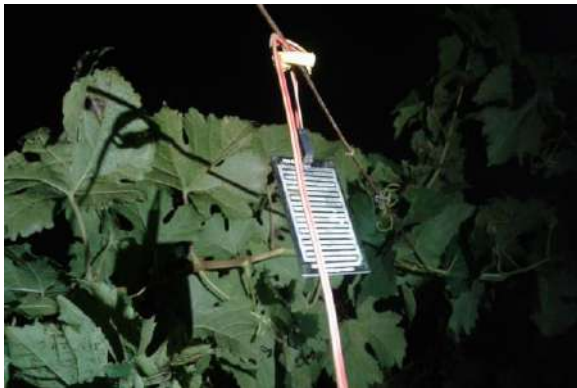
Fig: Rainfall sensor to monitor rainfall

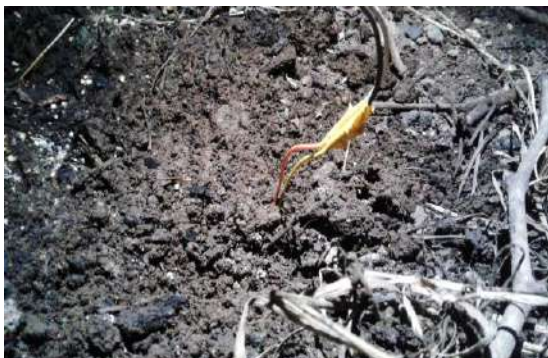
Fig: Soil moisture level measurement

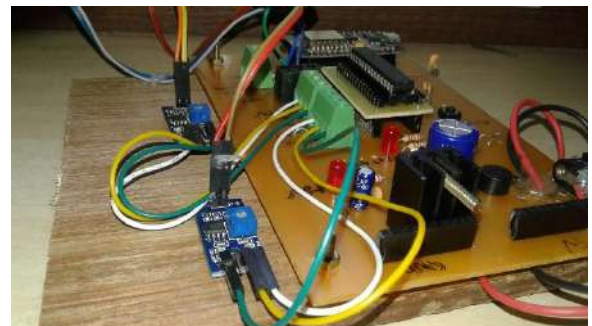
Fig: Actual Hardware of project
